Lead-Based Paint Inspection and Risk Assessment (LIRA) Report

3754 N 15th St – Single
Milwaukee, WI 53206

4698-LIRA

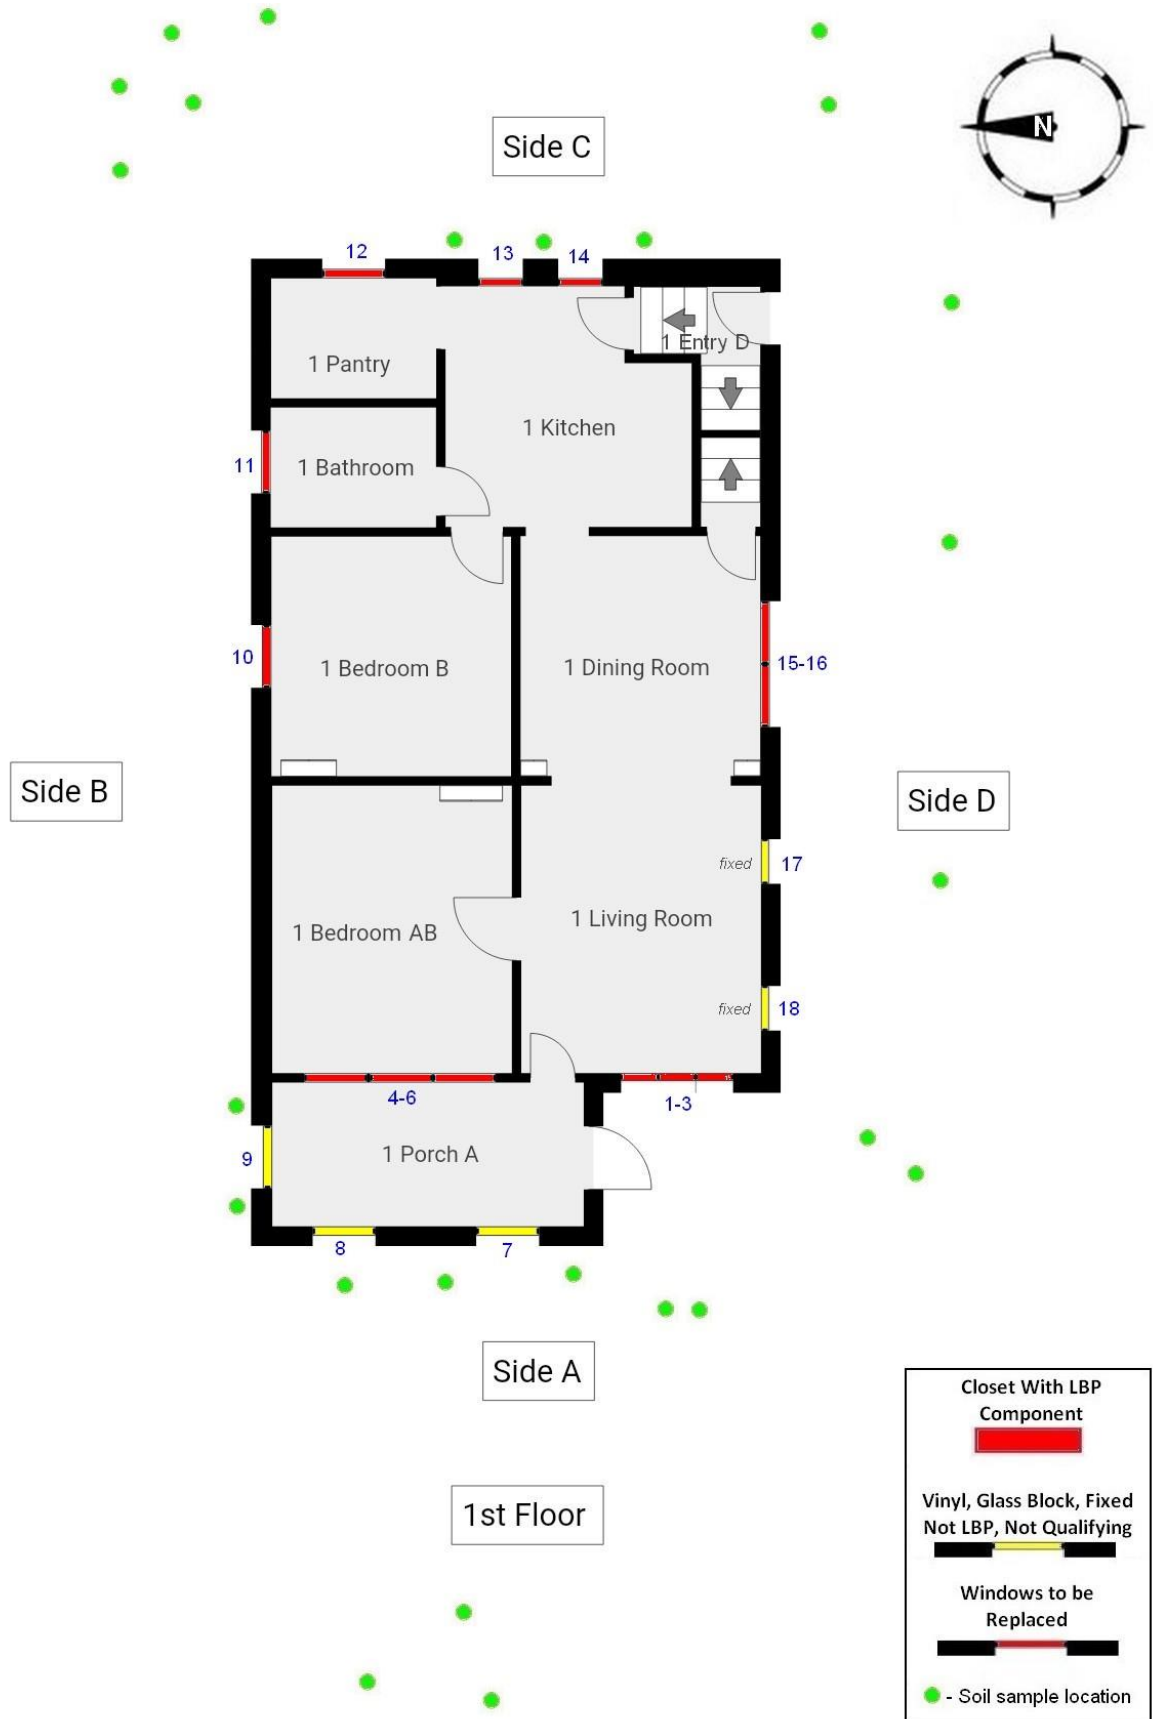
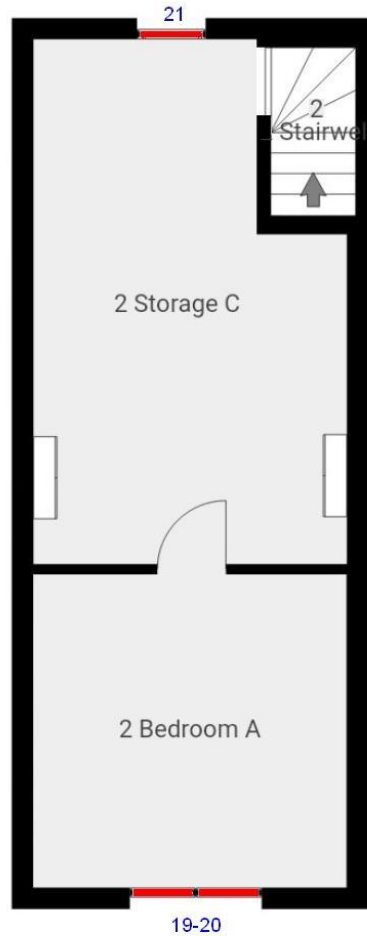
APPENDIX C: Floor Plan(s) and Site Sketch

Windows to be Replaced

● - Soil sample location

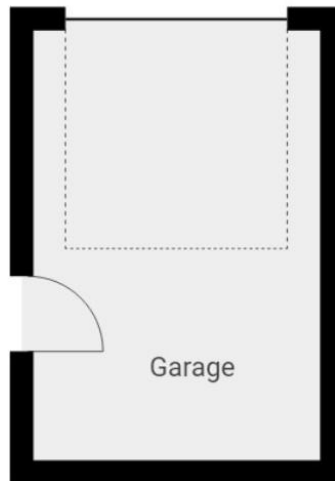
Garage
